KIRBY INLAND MARINE, LP 55 WAUGH DRIVE, SUITE 1000 HOUSTON, TEXAS 77007 DEZAVALA FLEET SHORELINE REPAIRS AT CARPENTER'S BAYOU & BUFFALO BAYOU IN CHANNELVIEW, HARRIS COUNTY, TEXAS

## ND GEOTUBE SHORELINE PROTECTION 5 1 \* 12.00 1/45 MATCHLINE SEE DWG. 4 OF 6 MATCHLINE SEE DWG. 4 OF 6

DEZAVALA FLEET SHORELINE REPAIRS AT CARPENTER'S BAYOU & BUFFALO BAYOU IN CHANNELVIEW, HARRIS COUNTY, TEXAS

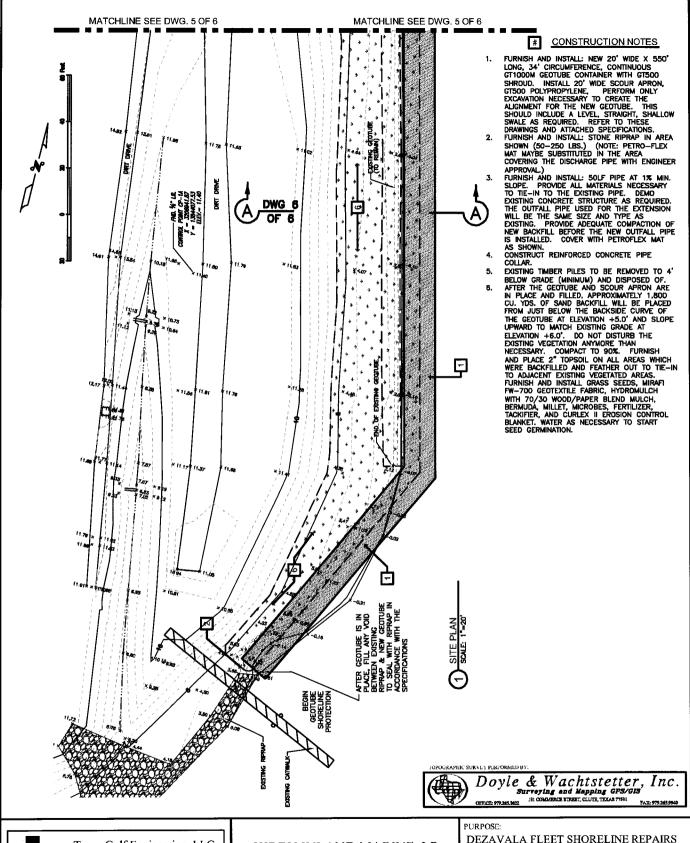
DATE: SEPTEMBER 6, 2012 SHEET: 4 OF 6

FURNISH AND INSTALL: NEW 20' WIDE X 550'
LONG, 34' CIRCUMFERENCE, CONTINUOUS
GT1000M GEOTUBE CONTAINER WITH GT500
SHROUD. INSTALL 20' WIDE SCOUR APRON,
GT500 POLYPROPYLENE, PERFORM ONLY
EXCAVATION NECESSARY TO CREATE THE
ALIGAMENT FOR THE NEW GEOTUBE. THIS
SHOULD INCLUDE A LEVEL, STRAIGHT, SHALLOW
SWALE AS REQUIRED. REFER TO THESE
DRAWINGS AND ATTACHED SPECIFICATIONS.
FURNISH AND INSTALL: STONE RIPRAP IN AREA
SHOWN (50–250 LBS.) (NOTE: PETRO-FLEX
MAT MAYBE SUBSTITUTED IN THE AREA
COVERING THE DISCHARGE PIPE WITH ENGINEER
APPROVAL.)

COVERING THE DISCHARGE PIPE WITH ENGINEER APPROVAL.)
FURNISH AND INSTALL: 50LF PIPE AT 1% MIN. SLOPE. PROVIDE ALL MATERIALS NECESSARY
TO TIE-IN TO THE EXISTING PIPE. DEMO EXISTING CONCRETE STRUCTURE AS REQUIRED. THE OUTFALL PIPE USED FOR THE EXTENSION WILL BE THE SAME SIZE AND TYPE AS EXISTING. PROVIDE ADEQUATE COMPACTION OF NEW BACKFILL BEFORE THE NEW OUTFALL PIPE IS INSTALLED. COVER WITH PETROFLEX MAT AS SHOWN.

CONSTRUCT REINFORCED CONCRETE PIPE COLLAR.

EXISTING TIMBER PILES TO BE REMOVED TO 4'
BELOW GRADE (MINIMUM) AND DISPOSED OF,
AFTER THE GEOTUBE AND SCOUR APRON ARE
IN PLACE AND FILLED, APPROXIMATELY 1,800
CU. YOS. OF SAND BACKFILL WILL BE PLACED
FROM JUST BELOW THE BACKSIDE CURVE OF
THE GEOTUBE AT ELEVATION +5.0' AND SLOPE
UPWARD TO MATCH EXISTING GRADE AT
ELEVATION +5.0'. DO NOT DISTURBE THE
ELEVATION +5.0'. DO NOT DISTURBE THE UPWARD TO MATCH EXISTING GRADE AT ELEVATION +6.0°. DO NOT DISTURB THE ELISTING VEGETATION ANYMORE THAN NECESSARY. COMPACT TO 90%. FURNISH AND PLACE 2" TOPSOIL ON ALL AREAS WHICH WERE BACKFILLED AND FEATHER OUT TO TIE-IN TO ADJACENT EXISTING VEGETATED AREAS. FURNISH AND INSTALL GRASS SEEDS, MIRAFI FW-700 GEOTEXTILE FABRIC, HYDROMULCH WITH 70/30 WOOD/PAPER BLEND MULCH, BERMUDA, MILLET, MICROBES, FERTILIZER, TACKFIER, AND CURLEX II EROSION CONTROL BLANKET. WATER AS NECESSARY TO START SEED GERMINATION.

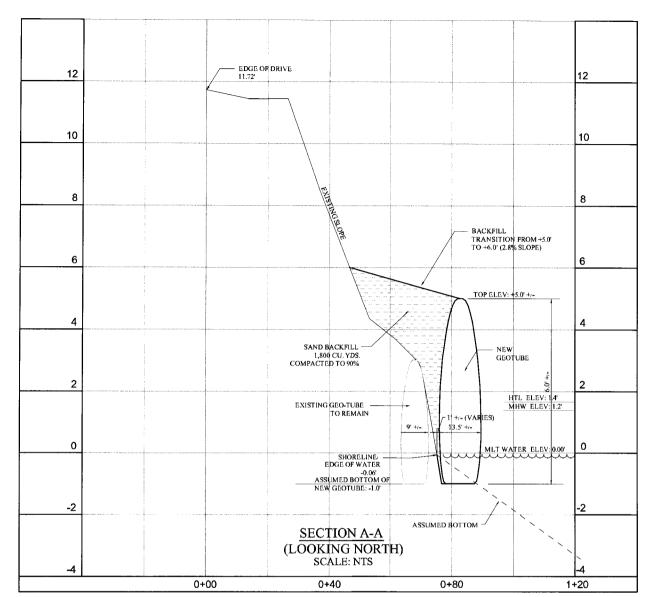
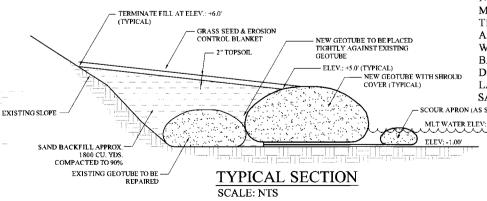
DATE: SEPTEMBER 6, 2012 SHEET: 5 OF 6

NOTE: ELEVATIONS BASED ON MEAN LOW TIDE (MLT) DATA. HIGH TIDE LINE (HTL) ELEVATION IS APPROXIMATE. MEAN HIGH WATER (MHW) ELEVATION IS BASED ON COOPS/NGS ELEVATION DATA AT THE LYNCHBURG LANDING STATION ID 8770733 IN SAN JACINTO, TEXAS.

SCOUR APRON (AS SHOWN ON DWGS.) MLT WATER ELEV: 0.00
